## Front Upper Control Arm-to-Frame Mounting Bracket Attachment

### Initial Inspection

### Mounting Bracket Inspection

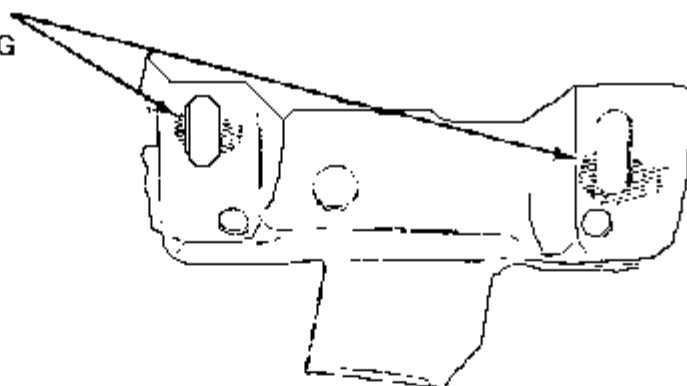
GOOD CONDITION  
RETORQUE RETAINING  
BOLTS, SET FRONT  
WHEEL ALIGNMENT  
AND RELEASE  
VEHICLE

6. If distinct diamond pattern is visible and not marred in any fashion, reassemble the upper control arm to the mounting bracket. Position the upper arm shaft near the center of the slot adjustment range and install bolts and nuts. Tighten to 163-190 N-m (120-140 ft-lb). Move the vehicle to alignment rack and set front end alignment to specification. Release the vehicle.
7. If the frame "mounting" bracket is worn, gouged, exhibit signs of metal thinning or other forms of metal removal or wear indicating there has been movement between the front suspension upper arm shaft and the mounting bracket, repair the bracket by installing support washers. Go to **SUPPORT WASHER INSTALLATION**.
8. If the bracket is cracked, split or torn, replace the bracket.

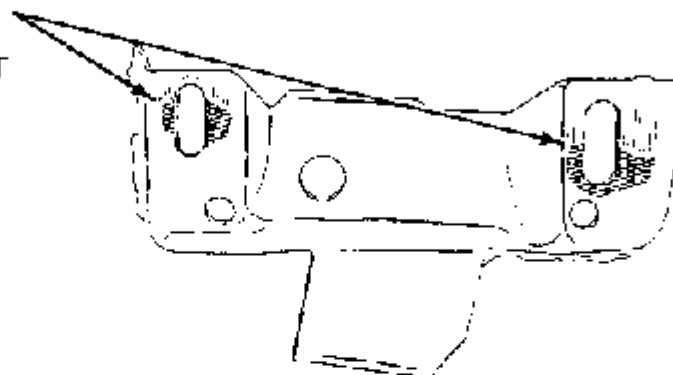
SLIGHTLY DAMAGED  
INSTALL SUPPORT  
WASHERS, SET FRONT  
WHEEL ALIGNMENT  
AND RELEASE  
VEHICLE

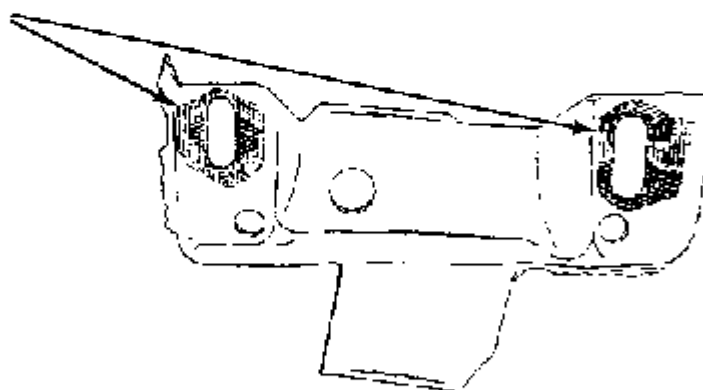
BADLY DAMAGED  
INSTALL SUPPORT  
WASHERS, SET  
FRONT WHEEL  
ALIGNMENT AND  
RELEASE VEHICLE

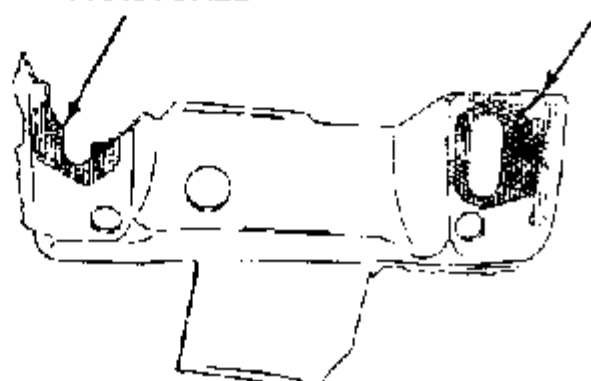
BRACKET  
FRACTURED

BRACKET  
CRACKED

REPLACE BRACKET  
SET FRONT WHEEL  
ALIGNMENT AND  
RELEASE VEHICLE

Brackets will come with a support washer and fastener kit. Discard the support washer from this kit and use only the bolt, lock washer and nut assembly to reattach upper arm to bracket.
